St John the Evangelist Church Survey

SEE Spatial & Geophysics

2021

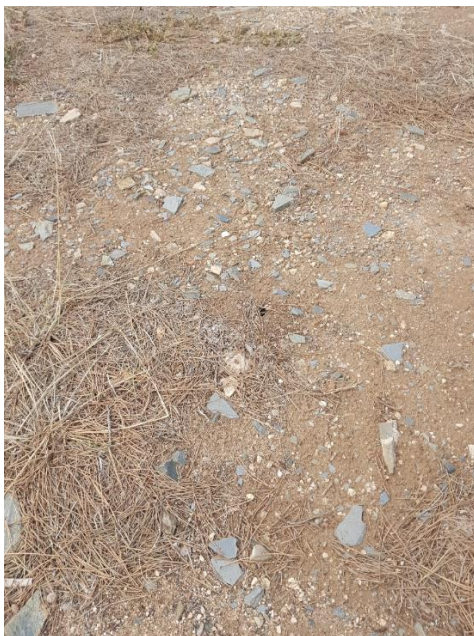
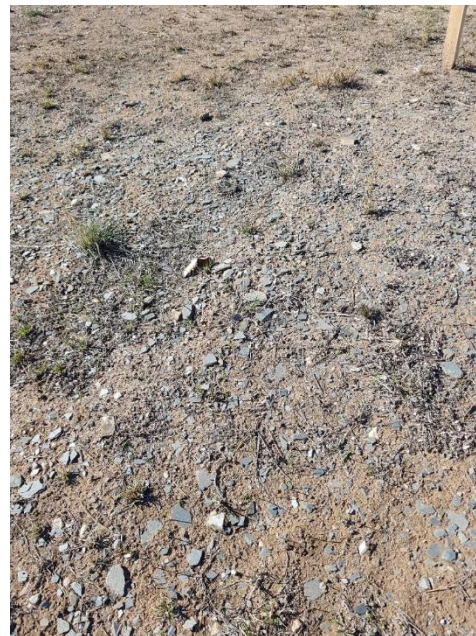
Figure 1: Examples of the scattered rubble.

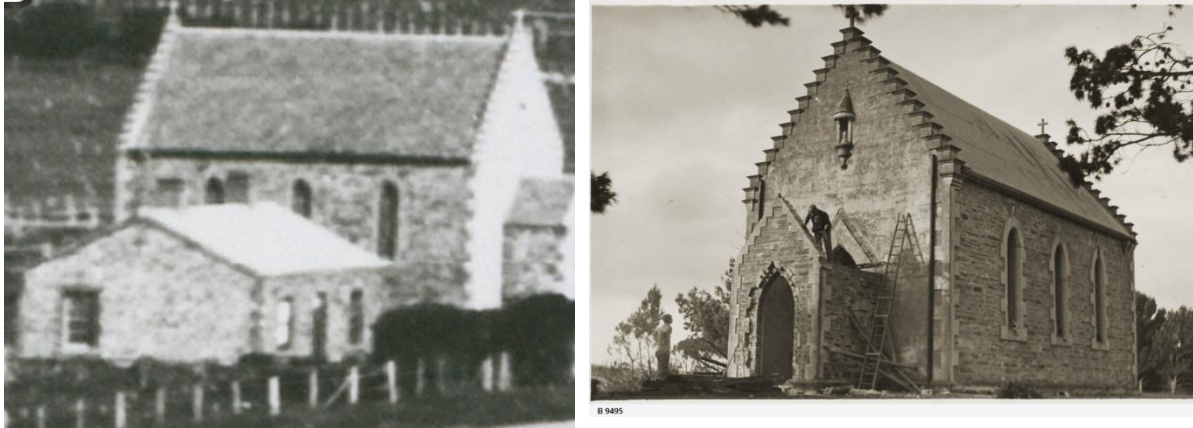
Figure 2: St John the Evangelist Church. Left 1898 and right being demolished in 1936. Both photos courtesy State Library. Catalogue numbers B17124 and B9495.

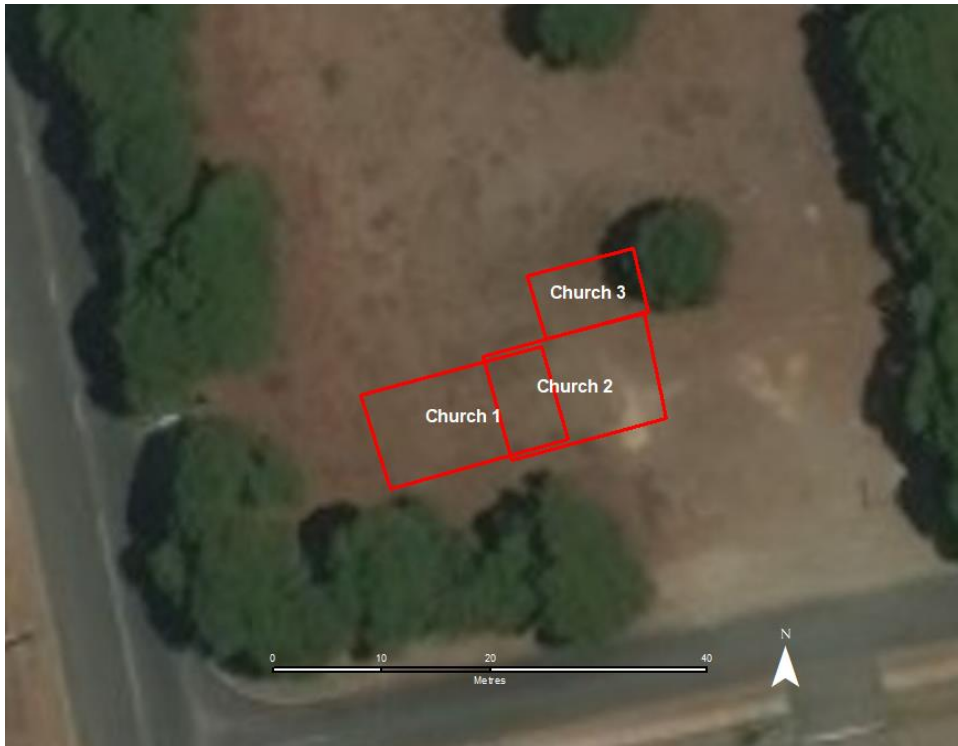
All GPR data was collected in grids, with these grids being various sizes. All GPR lines were at 0.5 m spacing. Three of these grids have been previously reported on.

Figure 3: The three GPR grids previously reported.

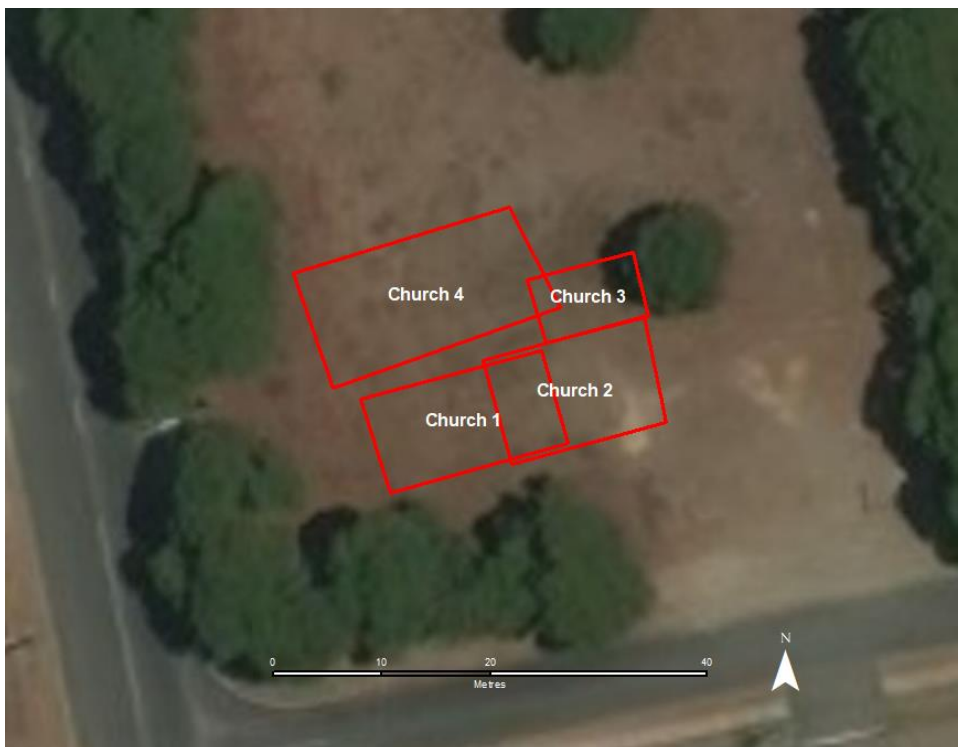
One further GPR grid was used to the north of these initial grids. This was placed to confirm the findings from the Gradiometer survey. All GPR lines were of west-east orientation, with 0.5 m spacing.

Figure 4: Location of the additional GPR grid, 'Church 4'.

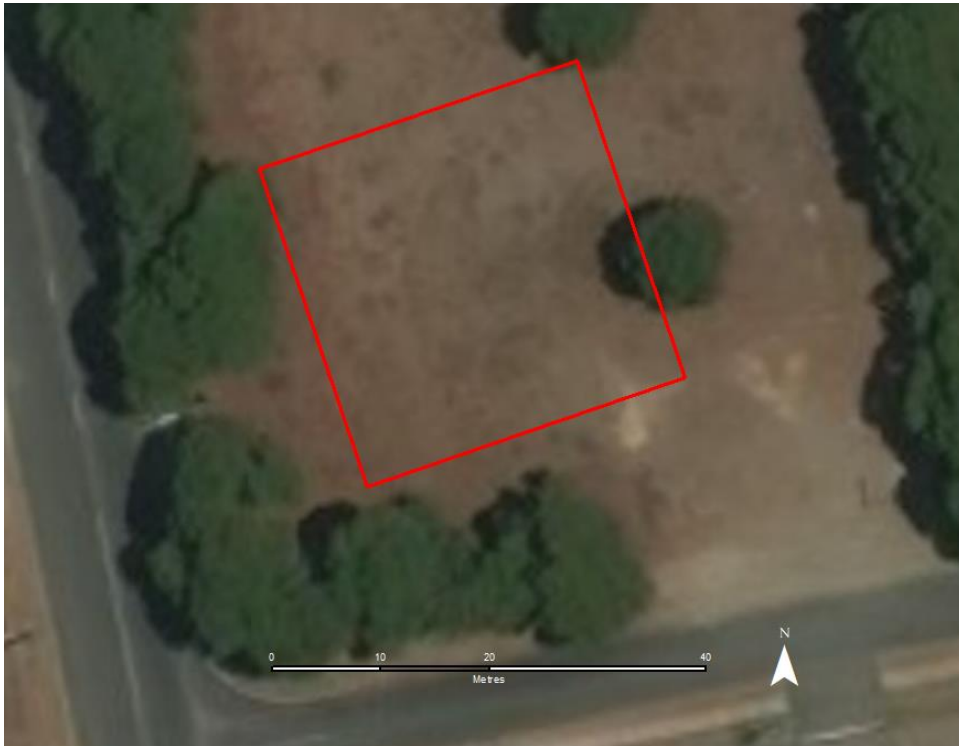
One large grid was used to collect the magnetic data. This grid was 30m x 30m, with data capture set at 2 lines per meter.

Figure 5: Location of the Gradiometer Grid.

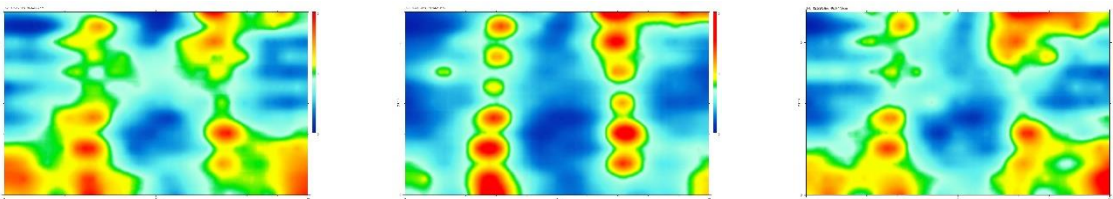
The interpretation of the initial grids has been reported in a previous report. In summary, processing data from these grids in GPR Slice showed, what looked like to be subsurface foundations, of a size and orientation that could possibly have been the church.

Figure 5: Depth slice of the Church GPR results. Left - 15.6-46.7 cm, centre - 31.1-62.3 cm and right - 46.3-77.5 cm.

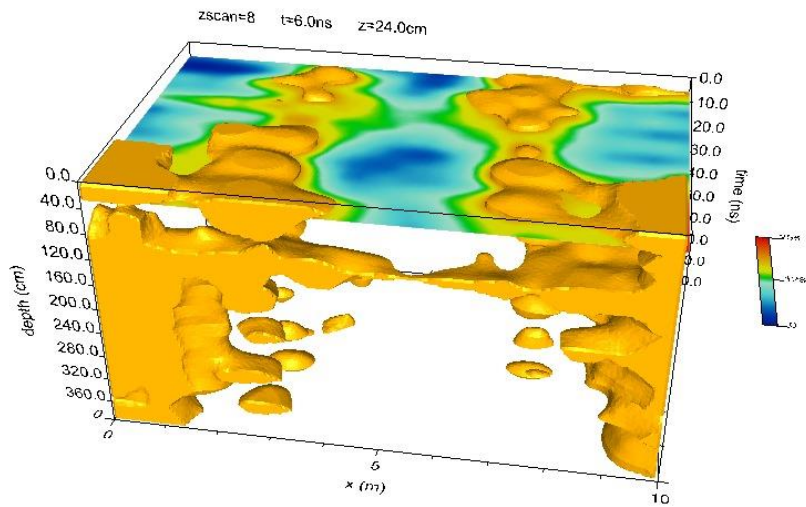
Figure 6: 3D render of Church picks from Grid 3.

The use of two geophysical methods in this survey has offered some surety in the interpretation of the data. The initial GPR survey of grids Church 3 did show some subsurface anomalies, that given the orientation and shape, could be argued to have been the remnants of the church. Further, subsequent, investigation of this area with the gradiometer failed to substantiate this. These subsurface anomalies could well be the remnants of a building, but not of the church.

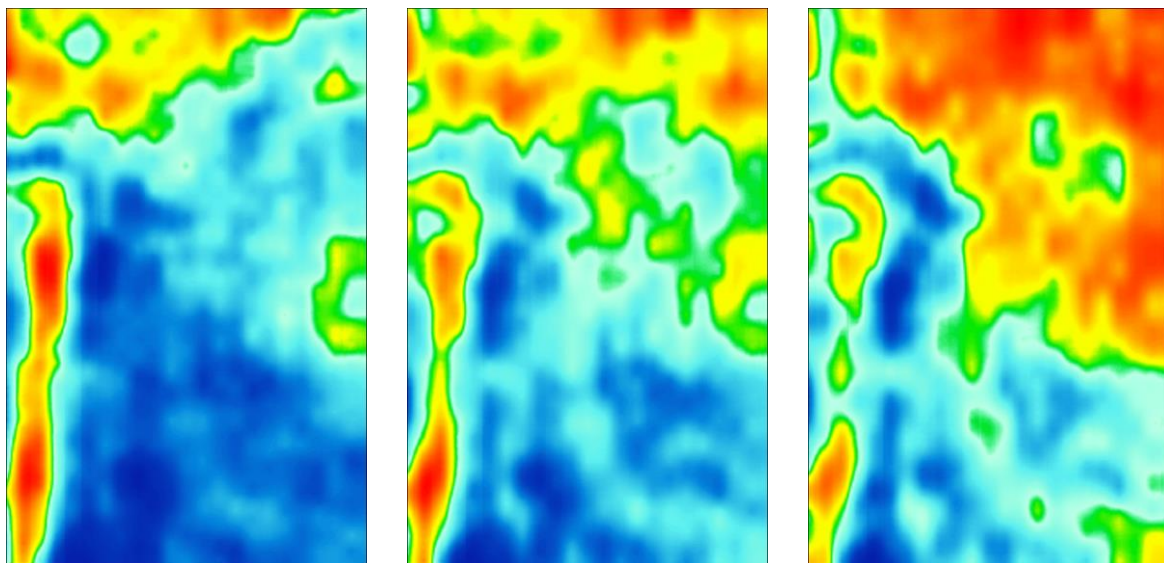
Figure 7: Depth slices, Church 4 grid. Left - 32.3 - 95.4 cm, centre - 63.7 - 127.4 cm and right - 95.9 - 159.6cm.

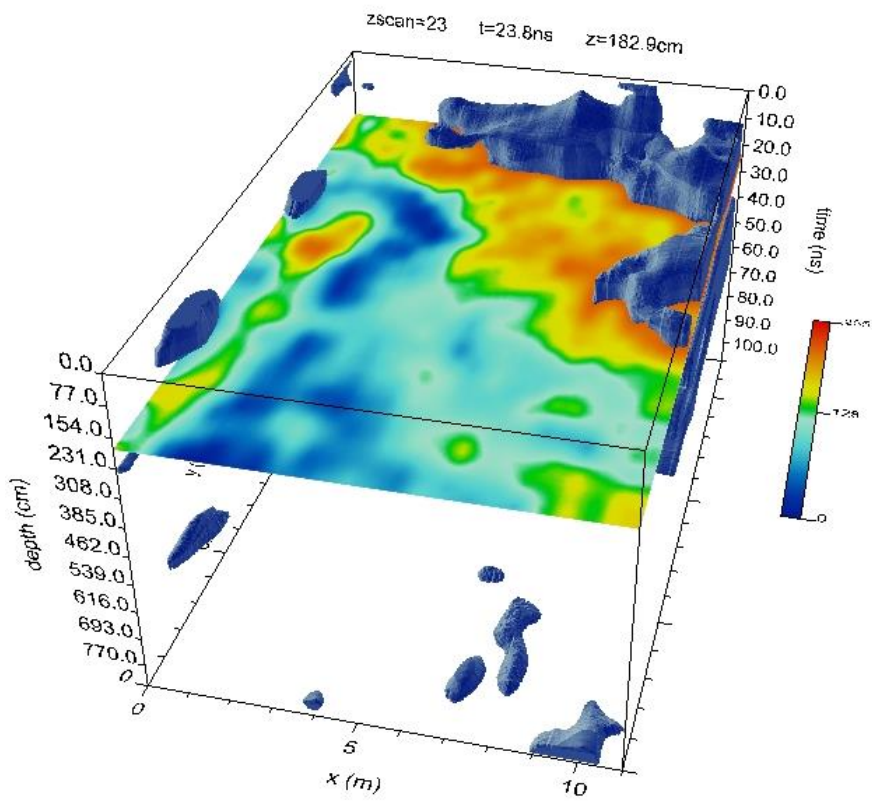
The new GPR grid (Church 4) was also rendered in 3D, see below.

Figure 8: 3D render of Church 4 grid showing possible foundation remnants.

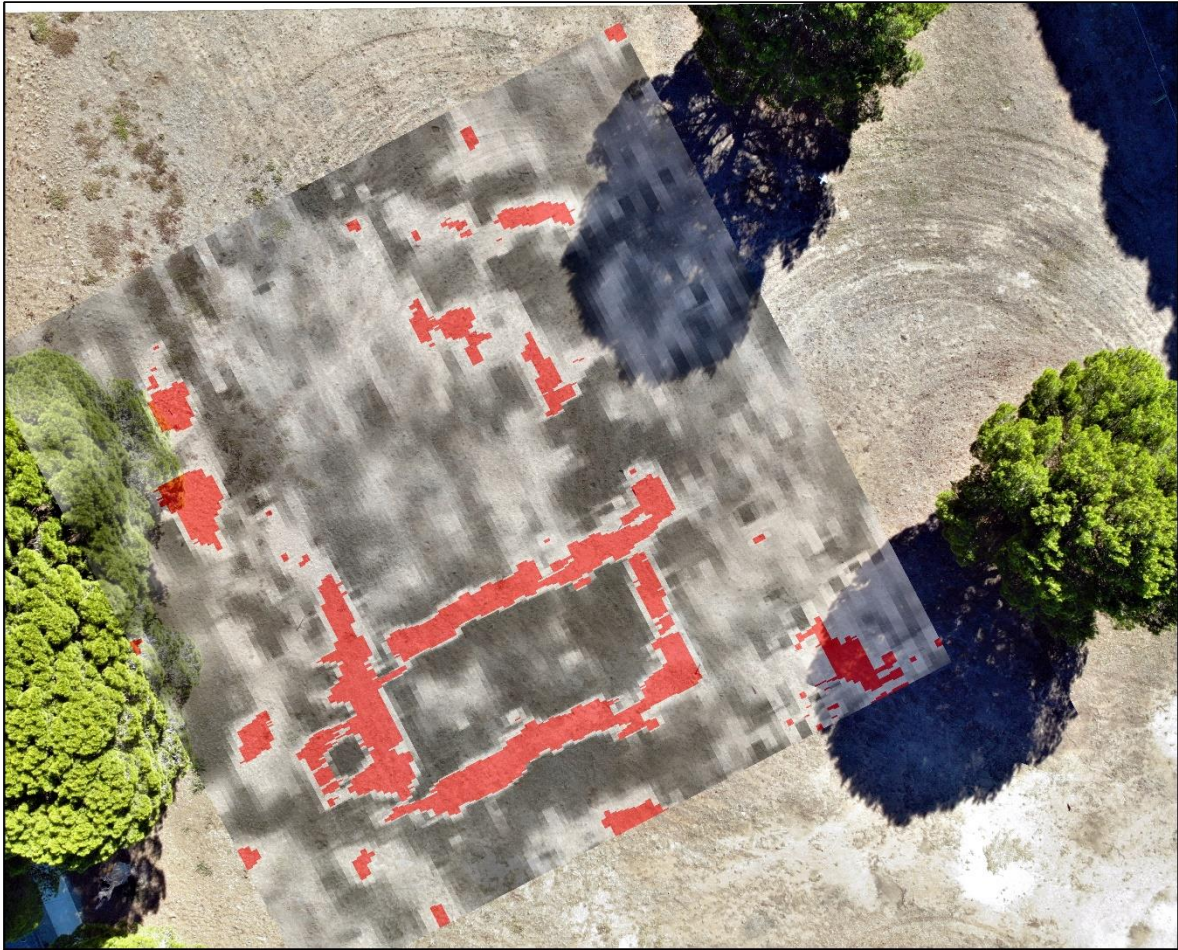
The results from the magnetic survey show what could be the outline of the foundations of the church.

Figure 9: Gradiometer results showing location and orientation of subsurface anomalies, possibly the Church.

The subsurface anomalies that the gradiometer has picked up is approximately 13.5 m x 7.2 m, and it can be seen that the shape and orientation is confirmed by historic photos sourced from the State Library of South Australia.

Shifting the focus of investigation a few meters north has gained results that do strongly suggest that this is the location of the church. It can be seen in the gradiometer results, figure 9, that there are subsurface anomalies to the south-east of the main building, these are consistent with the results from the initial survey. Also of note, there is no sign of the convent, which in the 1898 photo, does seem to be quite adjacent to the church.
